**Service information**

**Reference no.:** SDA\_113911\_E97\_G\_B\_HOUSINGPART

Improved bottom housing does not fit anymore

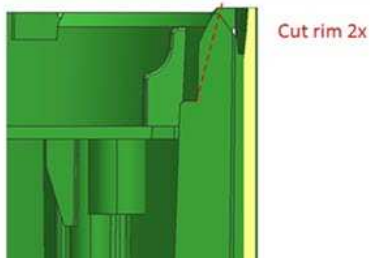
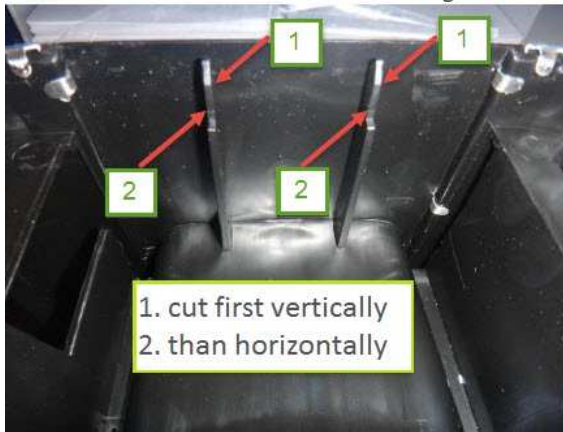
9965 100 64773 - Bottom housing

The improved bottom housing part 996510064773 used in HD776x does not fit on top housing part 996510064758 used in HD7761 & HD7762.

Modify (cut 2 rims, see pictures below) bottom housing part 996510064773 to make it fit again on the 996510064758 used in HD7761 & HD7762.
