Reference no.: SDA\_113992

Noise Pump when Steam trigger is pressed ( Model: GC77XX/HI77XX)

Title : Noise Pump when Steam trigger is pressed for GC77XX or HI77XX (FastCare)

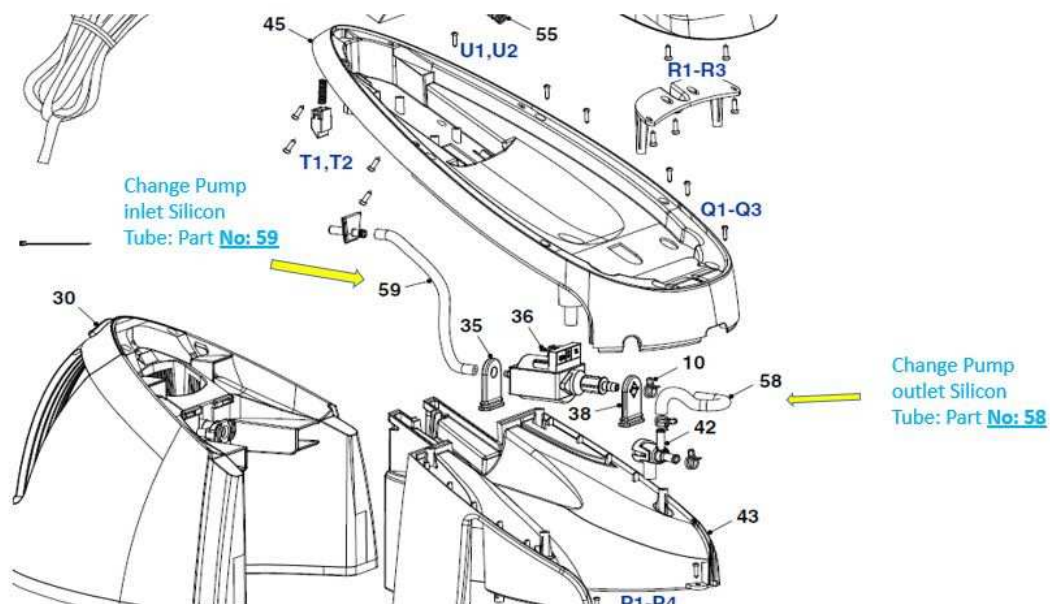
Root Cause: Customers Satisfaction issue, " Customer dissatisfy with the device Noise level when steam trigger is pressed".

Please kindly change both tube to reduce the Noise level as shows in the picture below.  
> Pump outlet Silicon fiber tube 12NC is 9965 100 75535 (length ~11cm)

> Pump inlet Silicon fiber tube 12NC is 9965 100 75536 ( length ~ 14 cm)

By changing the silicon tube, it will absorb the vibration & reduce the Noise level.
