Service information

Reference no.: SDA_77496

Hinge-joint broken off from brewhead Senseo latte select.

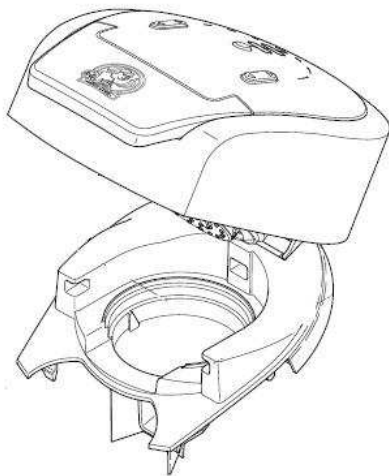
INFO:
Hinge-joint is broken off from brewhead Senseo latte select.

CURE:
Replace complete brewhead unit, see picture:

HD7850/8x => 4222 259 7480
HD7850/8x => 4222 259 42894
HD7852/5x => 4222 259 43844
