Service information

Reference no.: SDA_80579

Clogging / splashes in dispenser valve in Odea machines

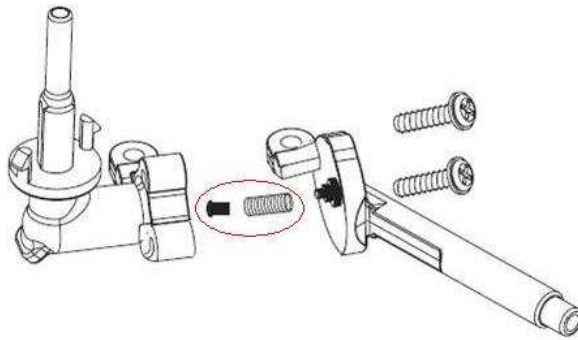
INFO:
Brewing valve gets clogged and/or there are splashes in coffee dispenser.

CURE:
The spring and the valve (see image 1) must be removed from brewing valve (indicated in the exploded view with the code: 11007647).
The counter piston must be replaced by the kit code 20005362 (see image 2) which is made without needle and without diaphragm.
