**Service information**

**Reference no.: SDA\_81286**

Prevention of descaler infiltration on gear motor wheels

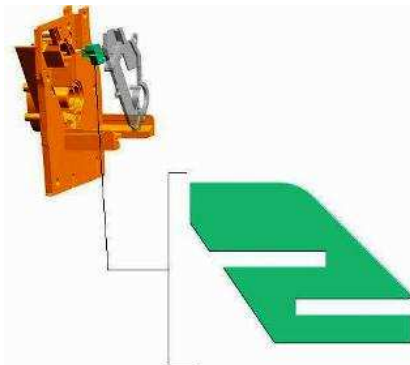
Infiltration of descaler solution from the multiway valve on the gear motor wheels in Talea, Odea, Espresso Italiano, Gaggia Platinum, Spidem My Coffee, Privilege Cafè Crema and Migros Caruso Imperiale series.

Disassemble the mounting plate cover by unscrewing the three screws shown in the image 1.

Insert the mounting plate cover protection (image 2), part number 11022216, in the place shown in the image 3.
