**Service information**

**Reference no.: SDA\_83541**

Coffee leakage behind the spout of Senseo Quadrante

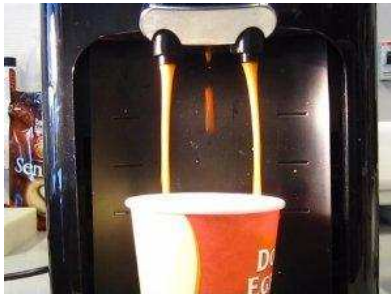
From the initial Fast Feedback it has come to our attention that some Senseo Viva Café appliances suffer from coffee leakage behind the spout. The rootcause for the leakage was traced back to the Pod Holder(s), the mounting of the plastic plate in the metal supports appears to be more critical than expected (though within specification).

Supply a new collector (4222 247 61280, on stock >WK1125) with the appliance, the new collector in combination with the pad holders will make sure no more leakage can occur. Do not replace the pod holders anymore.

A new collector design is finished, the stock @DHL will be converted >WK1125 Do NOT replace the pod holders anymore.
