## Service information

Steam/water leakage from stand

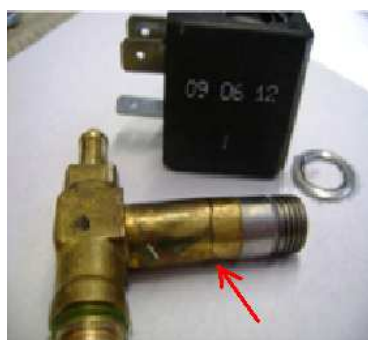
Cracks at boiler electro-valve will lead to steam/water leakage.  
The crack is the resultant of torsion stress during assembly process.

Please replace the defective electro-valve. Service code: 4239 017 10901.

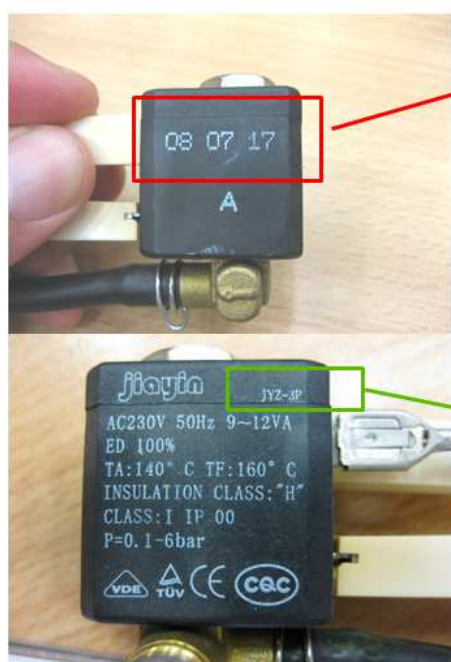
New electro-valve with improved design is introduced since 2010 July 23. The new part can be identified via the date code on the component body. Refer below picture.

#### Effective date code:

Year Month Date

10 07 23 or

2010 07 23

Electro-valve after this date – change implemented

Model: JYZ-3P

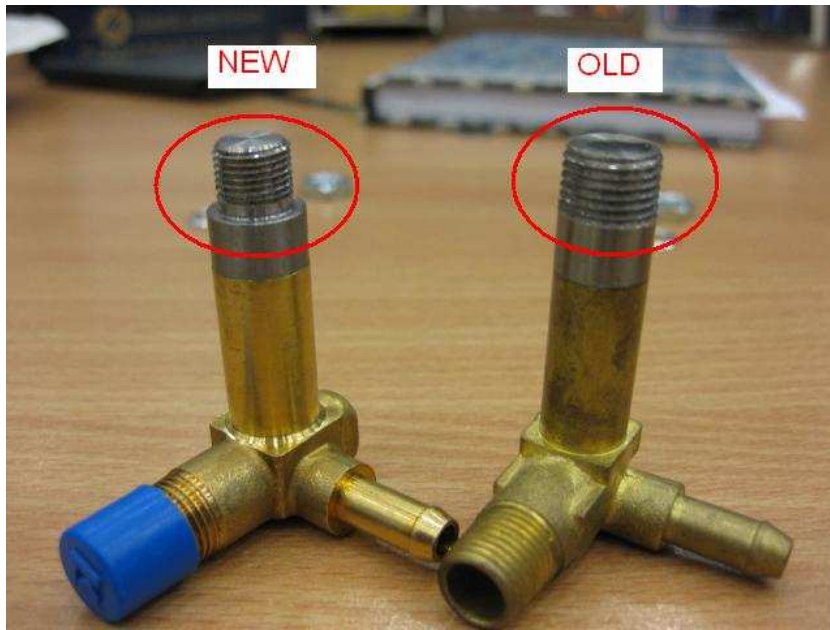
In addition, below picture shows the difference between the new part & the old part.

Use only the new electro-valve for service repair.
