Service information

UBL Bulletin DAP RV029

Title: my Senseo is leaking at the spout
From: Ruud Verbeek
Valid Country: EEU
Information for: All FL/BL agents
Date: 12//01/2011

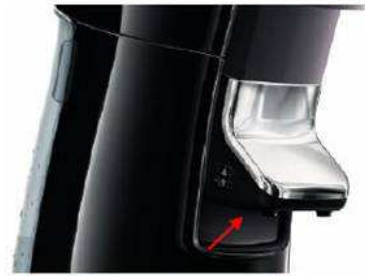
- ✚ Customer question; My Senseo is leaking Coffee at the spout (between the spout and the housing)

Models viva cafe: HD7825, HD7827, HD7835

Viva café collector: 4222 247 42551

Year / week nr: Products produced before week 1102 are infected.

Leakage at the spout is caused by an infective collector. Send the consumer a new collector and advise the consumers to clean the spout properly.
