#### Service information

Reference no.: SDA\_84870

Water or Steam leaking from Rinse tank interface during normal ironing usage

Applicable for GC9020, GC9040 and GC9140

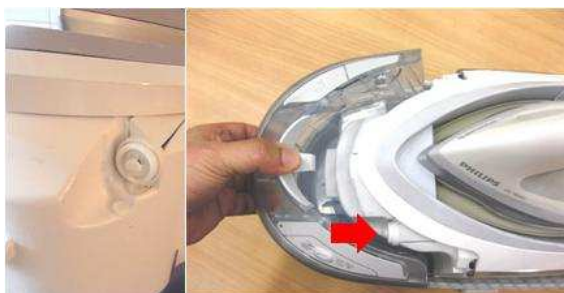
**Symptom:** Water or Steam leaking from Rinse tank interface during normal ironing usage (e.g. not Auto Calc Clean operation)

When rinse valve is unable to seal properly, unit will leak water and steam during heating up of the steam generator.

**Cure:** Replace CEME e-valve with Jiayin valve  
Electrovalve (90 deg) - diagraphm 4239 017 11581
