**Service information**

**Reference no.: SDA\_88902**

Water leaks from Easy De-calc (Perfectcare) knob

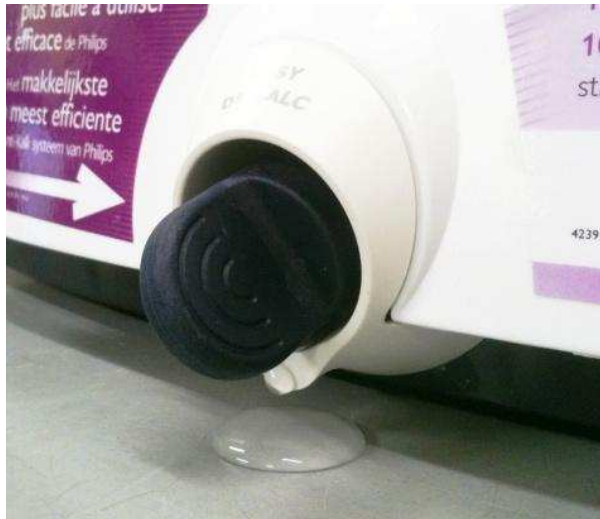
**Symptom:** Water leaks from Easy De-Calc knob

**Products Affected:** Perfectcare GC9200 series with production code Wk1120 to Wk1135

**Cause:** Water is leaking from the Easy De-Calc due to insufficient or improper sealing of the knob.

If knob shows no gap, it is likely Easy De-calc knob is insufficiently tighten, to seal, further tighten by another quarter turn.

Otherwise, Easy De-calc knob sealing is improper and requires re-assembly (steps 1 to 5).

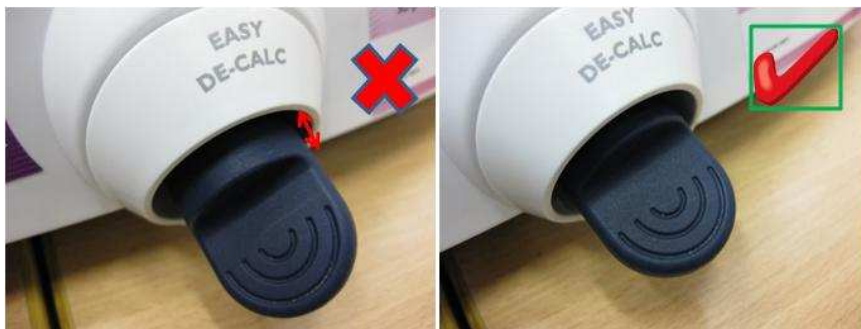
Two possible scenario:

- 1) Easy De-calc knob not aligned properly. From picture below, if aligned properly, there will be no spacing between Knob and stand body.
- 2) Easy De-calc knob is not tighten sufficiently

As the boiler contains hot water & steam, it is recommended to cool down boiler (2 hours) before taking remedy steps.

- 1) Unplug the power cord
- 2) Cool down the steam generator (approx 2h if the system is heated up)
- 3) Open the knob by turning it anti-clockwise till fully remove
- 4) Drain all the water
- 5) Ensure Knob is aligned with stand body and tighten the knob by turning clockwise. It would take about 3-4 complete turns to reach the sealing position

In the event that a sealing position is reached within 1 to 1.5 turns, it is likely the knob is not aligned properly or the screw thread on knob is damaged, a replacement part needs to be ordered.
