Service information

Reference no.: SDA_90226

Cracking of chromium in the coverage of the steam wand.

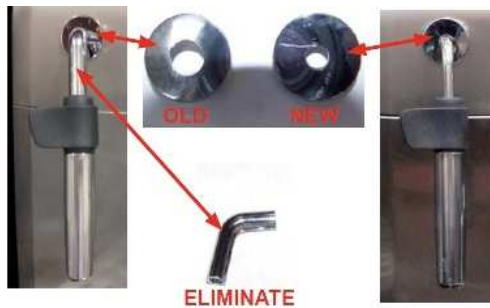
Possible cracking of chromium in the coverage of the steam wand.

The plastic chrome cover on the steam wand has been removed in the new Syntia production line, to avoid excessive clearance between the casing cover and steam wand, we also lowered the hole in the cap.

In case of cap replacement or customer complaint due to cracking of the cover of chrome steam wand remove the cover and insert the new cap with the smaller hole code 996530069616 (11027486).
