Service information

Reference no.: SDA_90560

SBS brew unit

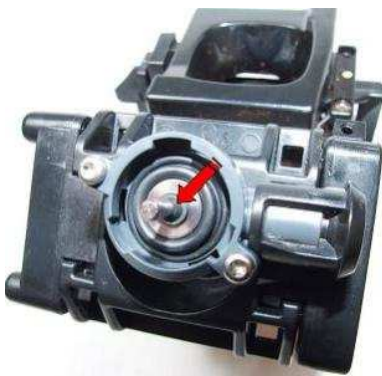
When the machine delivers a coffee product, the brewing group begins to emit a whistle sound at Xelsis and Exprelia line.

Remove the top of the valve, by turning and take it out (Image 1).

Remove the spring indicated (Image 2).

Eliminate the end of the spring (the last part),(Image 3).

Replace the spring with the cut side up to avoid damaging the gasket. (Image 4)
