Service information

Reference no.: SDA_90838

INFO:
Cleaning after repair and improvement of the brew unit lubrication.

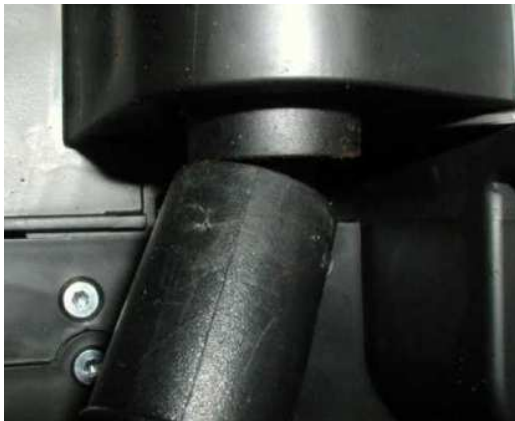
Image 1

- to keep the coffee which is already in the coffee channel from falling into the brew group (brew chamber) during transport, always clean the coffee channel by means of a vacuum cleaner (Image 1). Old grinder: Open the dispenser flap and empty the dosing chamber by means of a vacuum cleaner (Image 2). It is also possible to take a brush for cleaning.

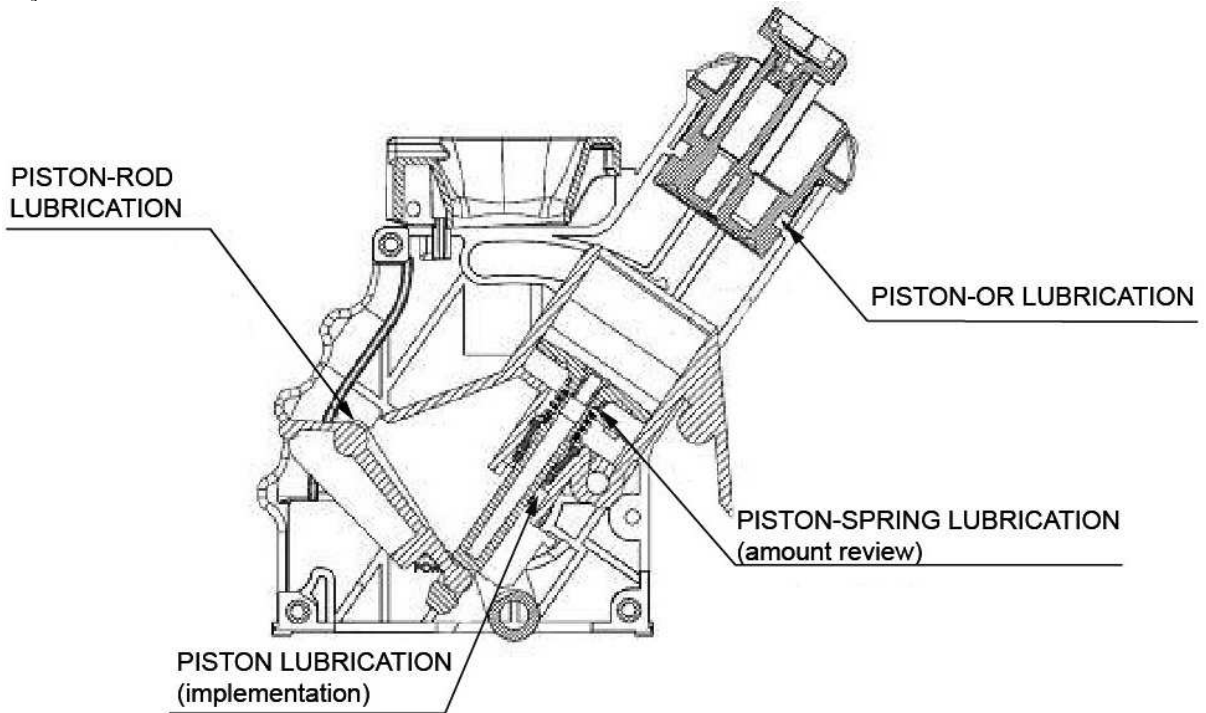
Image 5

- Lubricate of the brewing unit parts (Image 5), mainly focused in the piston rod (Image 6) to ensure the correct sliding on the gasket. For internal order cod. 11028379 KLUBER TUBE 5GR.
