#### Service information

Reference no.: SDA\_91928

Changing the front cover is very hard

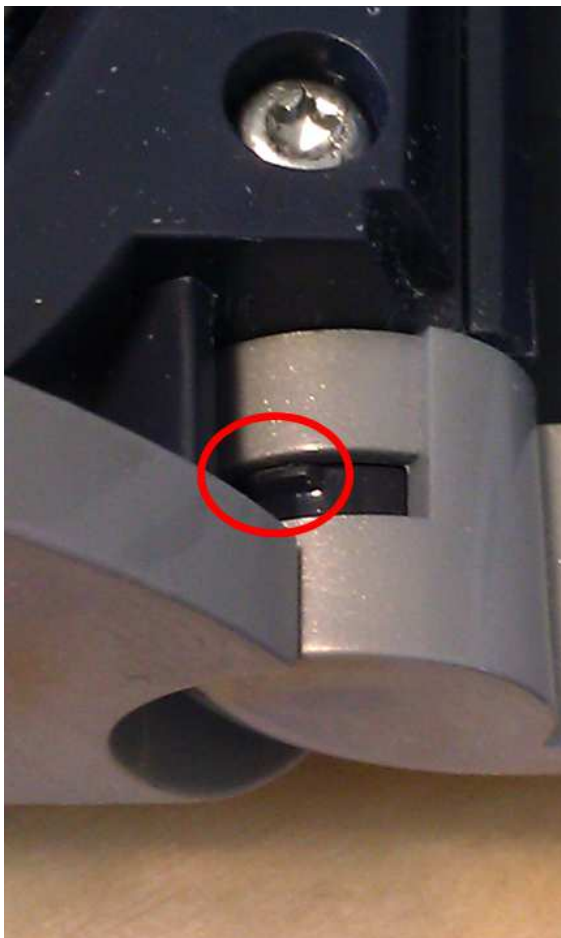
To replace the Hood assy more easily, you should first use a sharp tool to remove this fixation from the hinge of the hood. This is no problem, as the notches are part of the hood, not the nozzle and the hood will be discarded since this was the defective part in the first place. Then the Hood side panels (grey in the picture below) will be removable without breakage. The fixation notches are indicated in the picture below (in blue):

During training it was discovered that removal of the front cover (for instance when the notch activating the hood switch has broken off) is very hard. This is caused by the fixation of the Hood side panels (pos. 22 & 39) on the hinges.
