Service information

Reference no.: SDA_92093

Water leakage

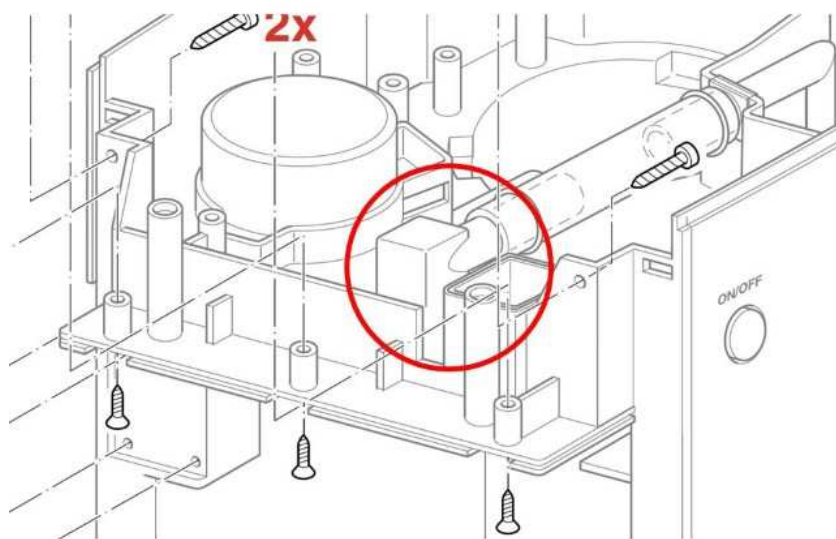
Remove the top cover from the appliance, underneath you can see the "shower head" which sprays the hot water into the coffee-filter.

...y seal the steam vent joint between the appliances frame and top cover, next to the shower head.) When you discover that the screws have been overturned / overtightened, it may help to fit slightly larger screws. It has been the case that the screw torque was not always well under control in the production line.

(Tip: exchange the overturned screw by a screw from the base plate (under the rubber feet), this screw is slightly longer, the screw from the showerhead also fits in the base plate.)
