Service information

Reference no.: SDA_93398

Detachment of the magnet in the carafe of milk in Xelsis line .

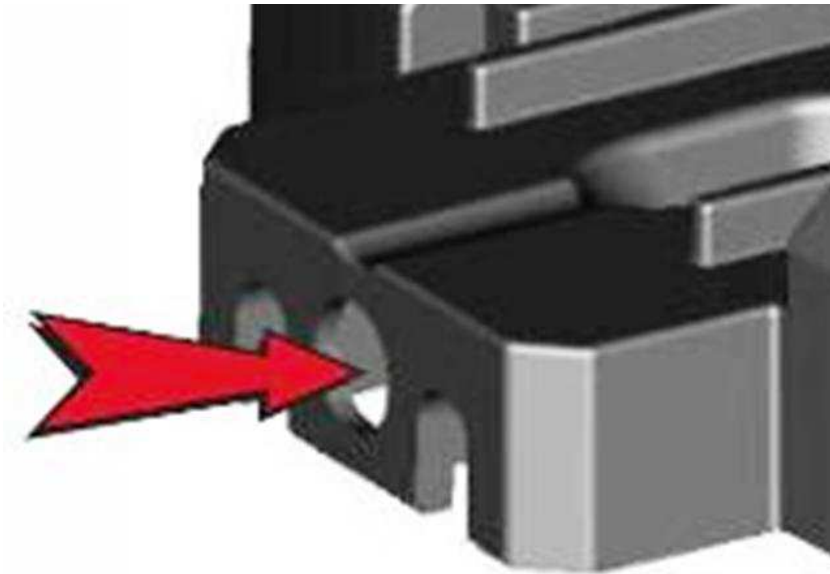
Image 1

INFO:
The zone of magnet part in the plastic component is to tight and could be damaged and break during the usage (image1).

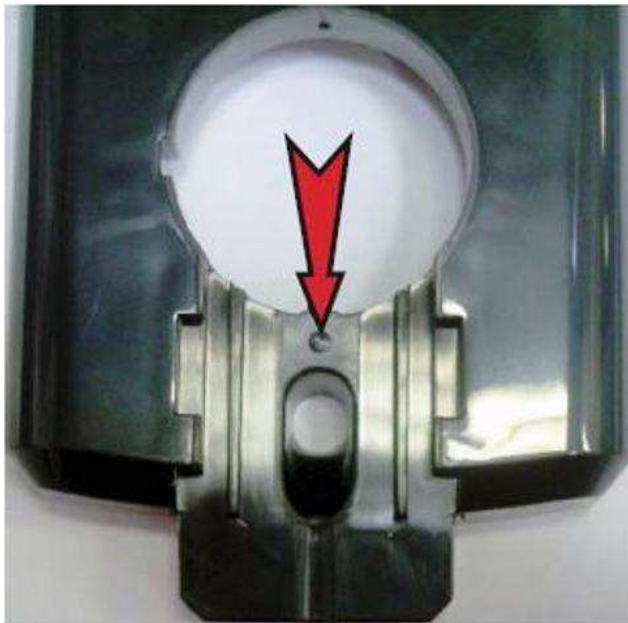
Image 2

CURE:
The magnet zone on the plastic component has been modified to remove any tight due to the presence of the magnet component inside the plastic support; the modified plastic part can be recognize by the circle sign on it as shown in the image 2. The code 11012816 remains unchanged.
