Service information

GC65xx Stand housing plastic degraded

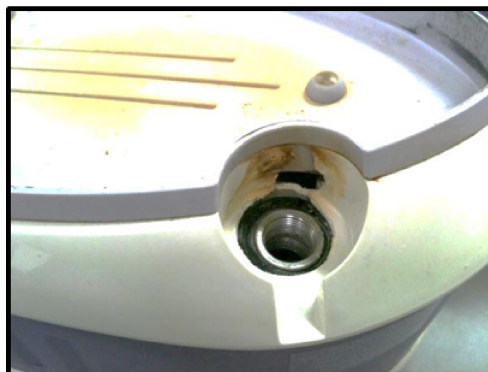
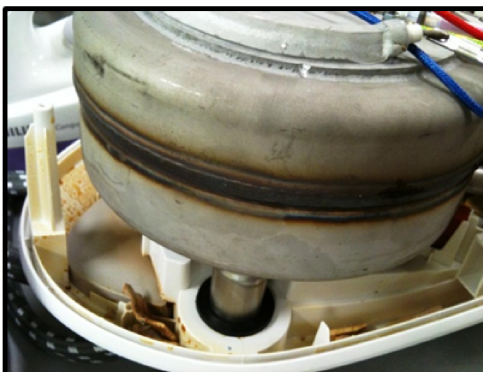
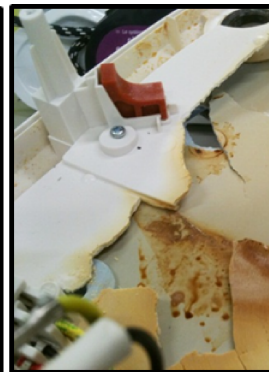
- Steam generator stand top housing degradation.

- Discoloration on iron tray.
- Unpleasant smell inside the steam generator.

- Overtime, the stand top housing cannot withstand the heat dissipated from the boiler and iron.

- Replace damaged stand top assy (Pos35 in service parts list)
- Add metal heat shield (Pos 57 in service parts list: 4239 010 12941) on stand top housing to reduce the temperature stress via better heat dissipation.
