Service information

GC86xx Water leakage from stand

Reference no.: SDA_9632

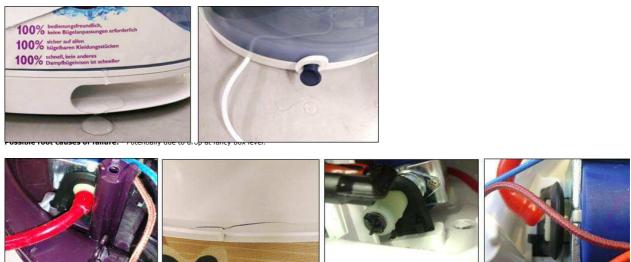
Symptom: - Water leaks from the bottom of the steam generator. - Water leaks at the side of the water tank.

Inlet tube torn

De-Air valve broken

Pump inlet coupling broken

- Replace Power board PCB-Pump service kit (Service code:4239 022 67101) for Inlet tube torn, De-Air valve broken and pump inlet coupling broken.

Remarks Product corrective action: All GC86xx products with date code > wk1250 will have additional packaging material installed during production. This improvement will improve the fancy box protection against drop related damages.
