Service information

Reference no.: SDA_98068

Damaged black inside cover front panel in Xelsis Line

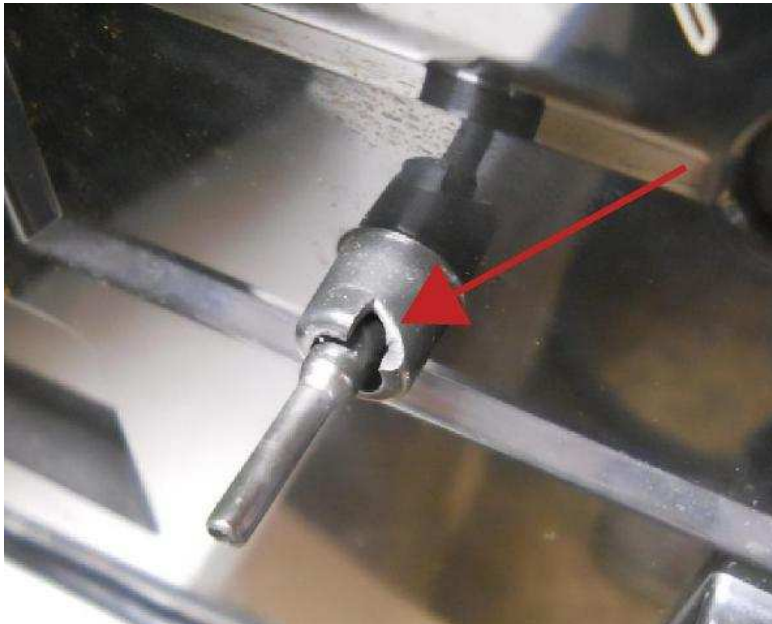
Image 1

Black inside cover front panel of door broken at dispenser coffee inlet.(See Image 1).

While closing the door, the dispenser coffee inlet that goes inside the brew unit hole, push the plastic ring on border and could damage it.

Replace the black inside cover frontal panel with new ones according to the below code and models matching table:

421944006981 BLK INSIDE COVER FRONT PANEL V4 MYB9/H **For Xelsis**

996530073363 BLK INSIDE COVER FRONT PANEL V3 MYB9/T **For Xelsis ID**
