Philips Consumer Lifestyle

Service Manual

PRODUCT INFORMATION

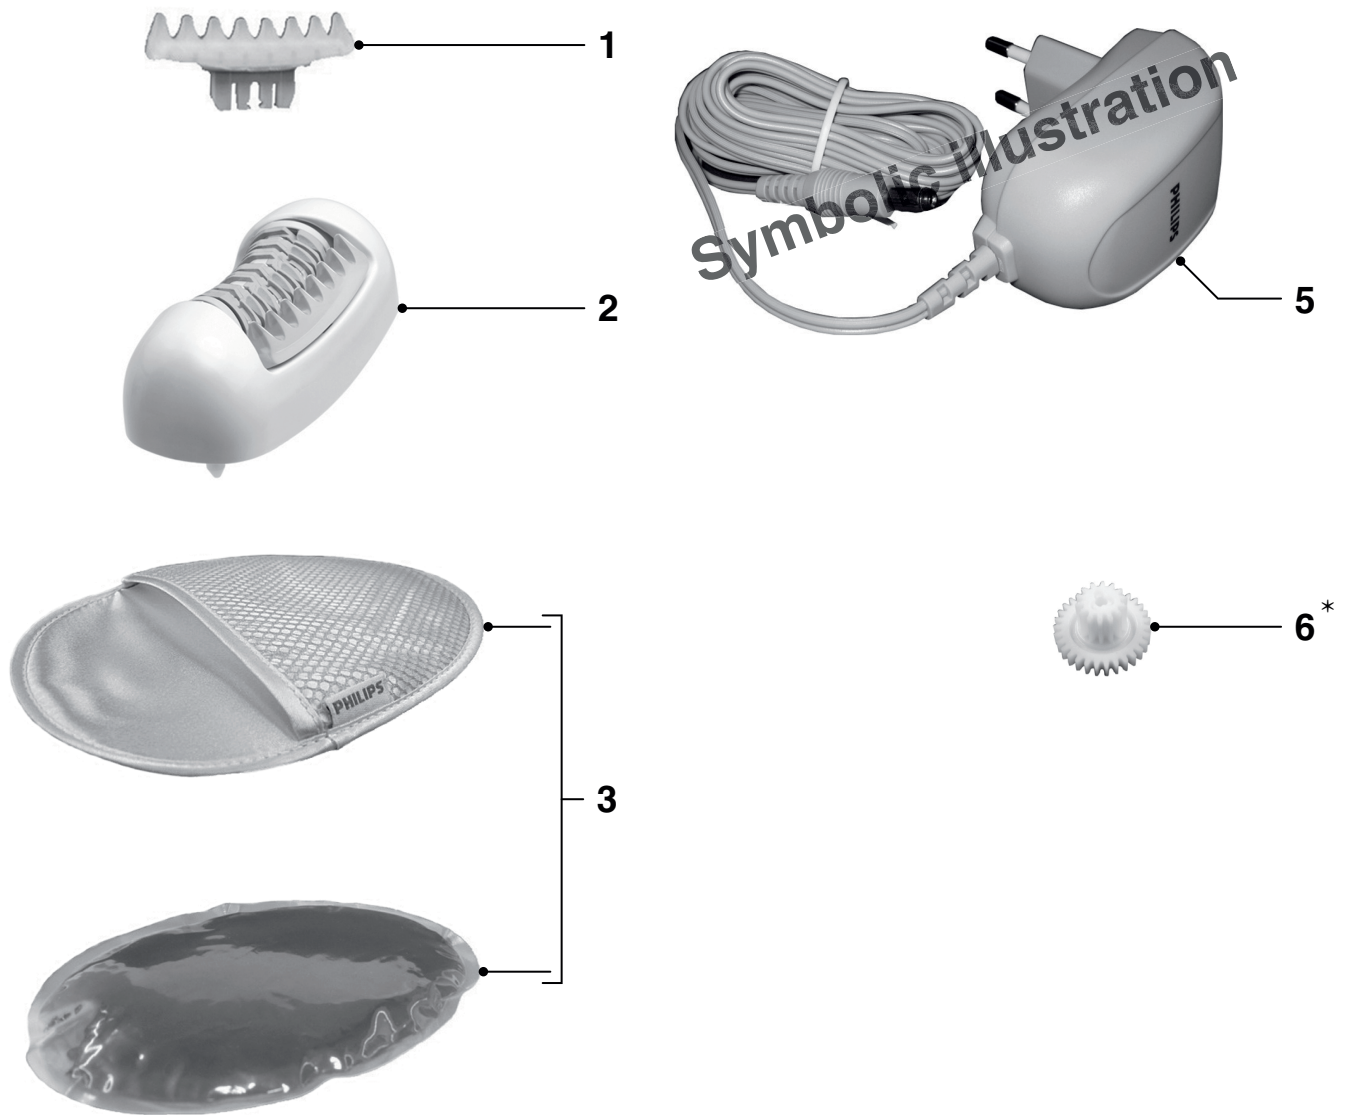
Pos	Service code	Description
1	4203 035 53990	Massage Attachment HP6481
2	4203 035 91701	Repair Kit (For products with production date till 744)
	4203 035 54170	Epilation Head new (From 744 onwards)
3	4203 035 86400	Cooling Glove + Cooling Pad
5	4203 035 51810	Adapter WEU
	4203 035 51900	Adapter GB
	4203 035 51860	Adapter ARG
	4203 035 51870	Adapter KR
	4203 035 51850	Adapter UNI - JPN/TW/USA/CD/MX
6*	4203 035 54180	Gearwheel 3 new (From 744 onwards)

- By ordering pos. 2 and pos. 6 see remarks in the partlist due incompatible between old and new parts.

* For replacing the gearwheel see the instructions on the next pages.

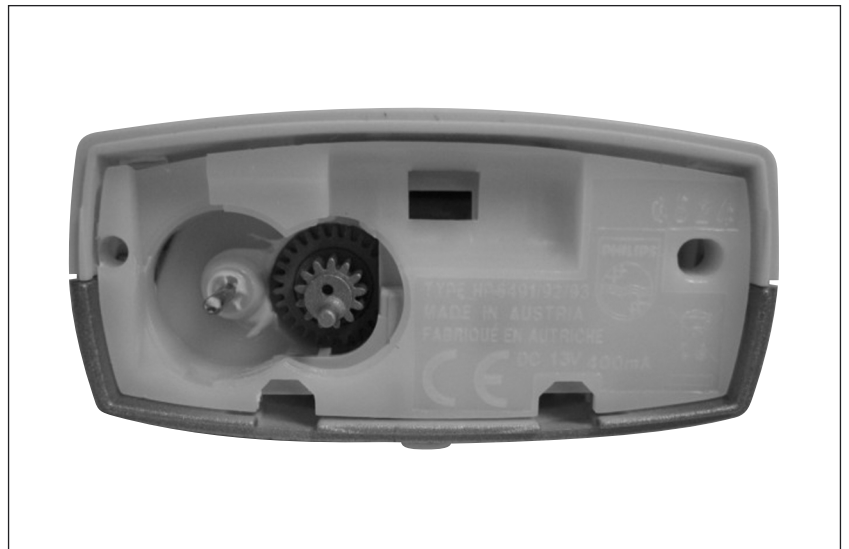
Now you are able to exchange the damaged gearwheel.

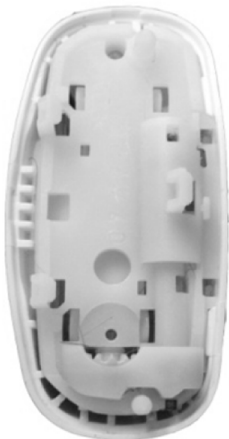
2. Preparing the epilating head.

4203 035 54170 Service Epi Head HP648x

4203 024 00561 EPI-Head
