Service information

Reference no.: SDA_87008

Steam and water pump function interchanged

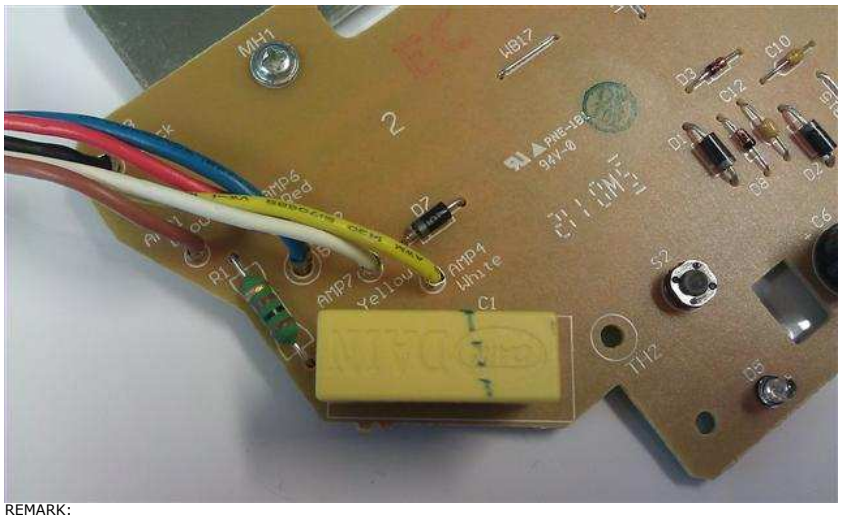
INFO:
it has come to our attention that there are incidents accurring with Senseo Latte or Cappuccino Select appliances, where apparently the function of the Steam and Water pump/heater is interchanged. Due to a manual repair process the possibility is introduced to reverse leads on the PCBA. This reversion is (apparently) not noticed during functional testing.

CURE:
Reverse the white and yellow leads on the PCBA, back to their original destination. The position marked "Yellow" should be occupied by the yellow lead, the position marked "White" should be occupied by the white lead.
