Service information

Reference no.: GDA_109196

New Improvements introduced on Gran Baristo and Minuto Carafe

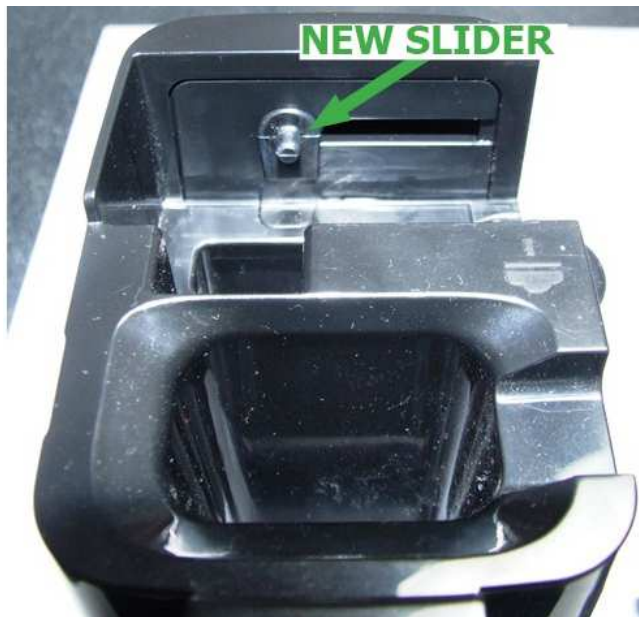
The Carafe has been improved by introducing both a new material and mechanism on the springer of the slider. The new material, by improving the thermal characteristics, makes the carafe more resistant to the high temperatures without being damaged.

For Gran Baristo and Minuto the code 17002207 (996530073573 BLACK UPPER COVER PART CARAFE SMR/T) is no longer available.

It was replaced by the KIT 421940813181 (KIT SPARES BLK UPPER COV.PAR.CARAF.SMR/T) to be used up to serial number: For Gran Baristo TU901430106019 (refer to the latest Exploded View available in AYS)
For Minuto TW901430450082 (refer to the latest Exploded View available in AYS)

In all machines returned to the workshop up to the mentioned serial numbers, insert the additional sheet 421944025201 with the instructions for consumer about the proper use of the milk carafe.
