Service information

Reference no.: GDA_113980

Wiring for programming with SSC2 is breaking.

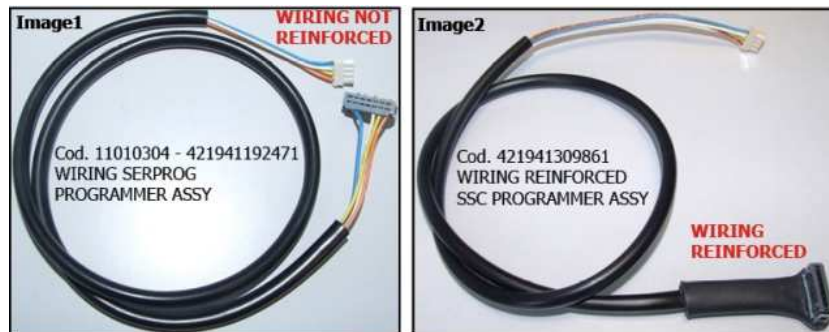
To avoid repeated failure to frequent use of the wiring (Image1) it has been created a reinforced wiring (Image2).

Standard Wiring (Image1): **11010304 421941192471 WIRING SERPROG PROGRAMMER ASSY**

Reinforced Wiring (Image2): **421941309861 WIRING REINFORCED SSC PROGRAMMER ASSY**

In case of frequent use, order the reinforced wiring (Image2)

Please note: The reinforced wiring does not fit on some machines (Xsmall and Intelia Cappuccino) because inflexibility. For these machines then use the standard wiring (Image1).
