Service information**Reference no.: GDA_97843****Symptom**

Seal on dirty watertank lid is damaged

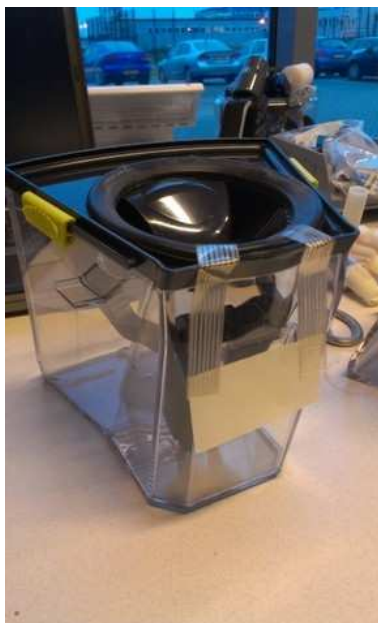
Seal on dirty watertank lid is damaged

2 tapes are added to assure that seal will stay at his place, see picture

Per wk. 1314 the tapes are added during assembly of the appliances
