**Service information**

**Reference no.: SDA\_103523**

Mandatory: insert sheet cleaning coffee powder duct Minuto

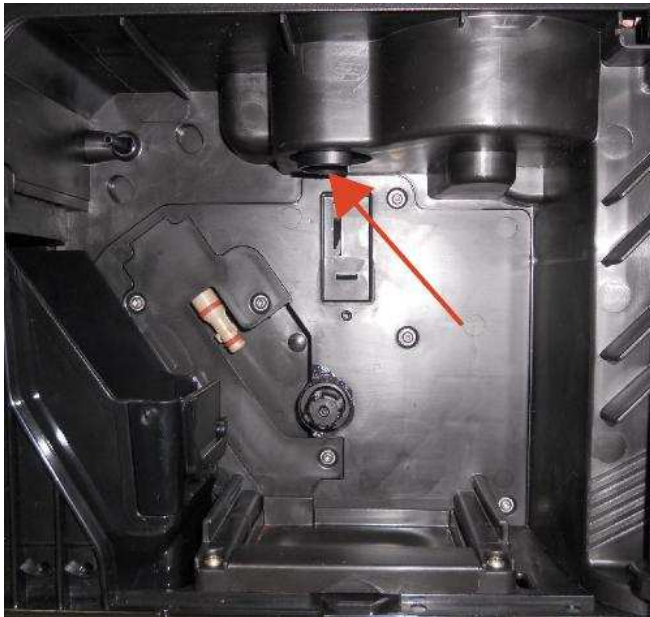
Image 1

The machine may not working properly because the coffee powder duct (shown by the arrow in Image 1) become clogged.

From S/N TW901406092406 the new additional sheet code 421946011131, with the instruction for cleaning coffee powder duct, has been inserted.

In all machine that return to workshop for any reason up to S/N TW901406092405, insert the additional sheet code 421946011131 that you find in the attached file.
