Service information

Reference no.: SDA_106612

Conveyor clogged by coffee powder

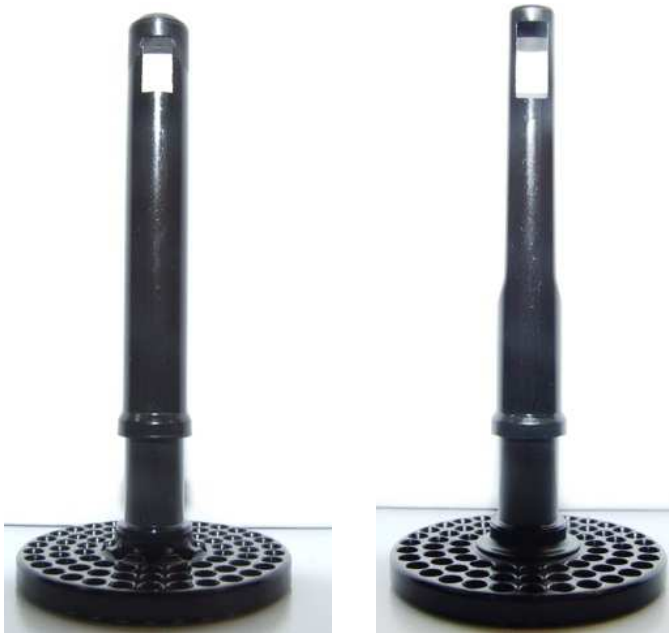
Piston component improved to solve the problem of conveyor occluded.

Replace the piston, 11003077, 421941154921 (image1), with the new one, code: 421944025621 (image2).
