Service information

Reference no.: SDA_107639

The Grinder doesn't work open circuit CPU board in Intelia / Intuita.

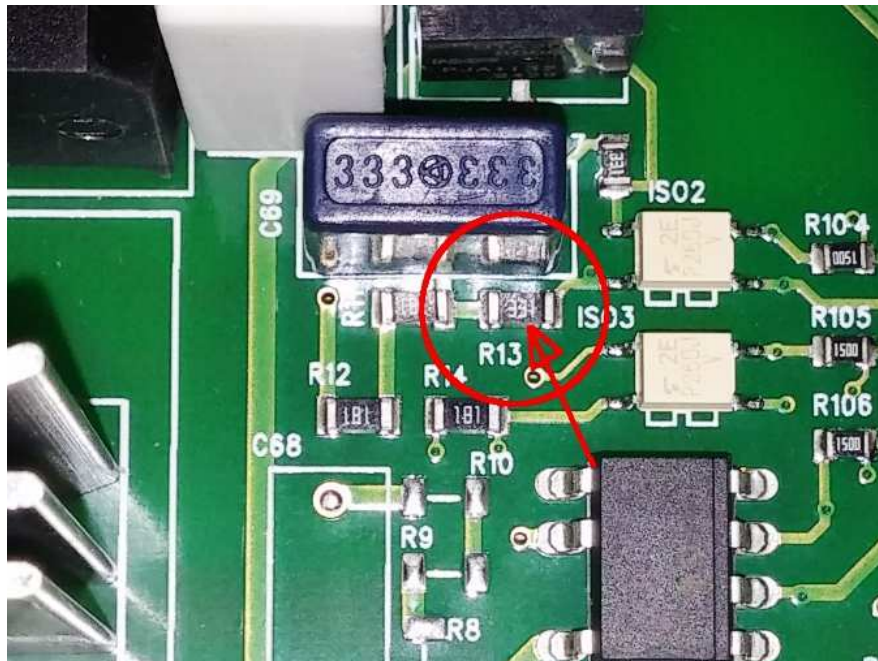
Image1

Check the R13 resistor (shown in the Images 1) by measuring the resistance (330 Ω) and if found defective "No Ohm value", proceed as follow:

- Repair the CPU Board by replacing the R13 resistor with the code **12002020 (996530073852)** RESISTOR 1206 330R 5% 0.25W. (Remark: by ordering code 12002020 (996530073852) you get 20 pieces of R13 resistor)
- In case is not possible to repair the CPU replacing only the resistor, the complete CPU Board replace is required (accordingly with the Exploded View documentation)
