Service information

Reference no.: SDA_108003

Appliance does not heat due to blown boiler TRIAC S2

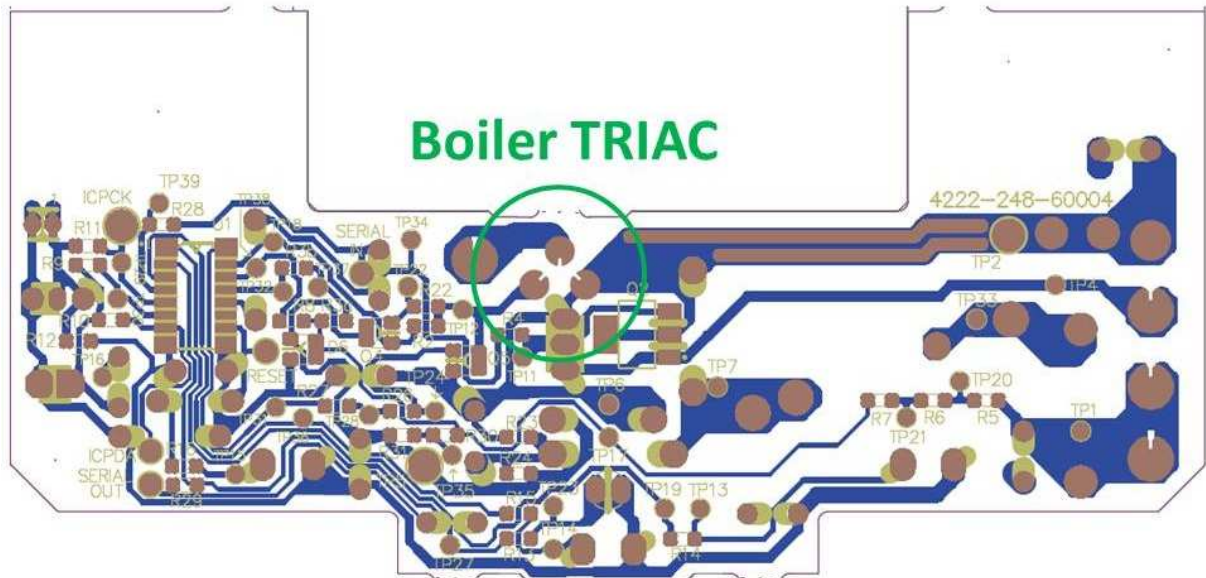
The cause for the Boiler TRIAC to blow, is likely to be an earth leakage of the boiler, therefore the boiler must be preventively replaced. Please refer to attached image for an overview of the back (solder side) of the PCBA, and the area to inspect.

Apart from the PCBA

- 422225952711 (for Plastic boiler)
- 422225954363 (for Metal boiler)

also replace the Boiler

- 422225952091 Plastic HV
- 422225949121 Plastic LV
- 422225953272 Metal
