Service information

Reference no.: SDA_108015

Appliance does not heat due to blown boiler TRIAC SVC

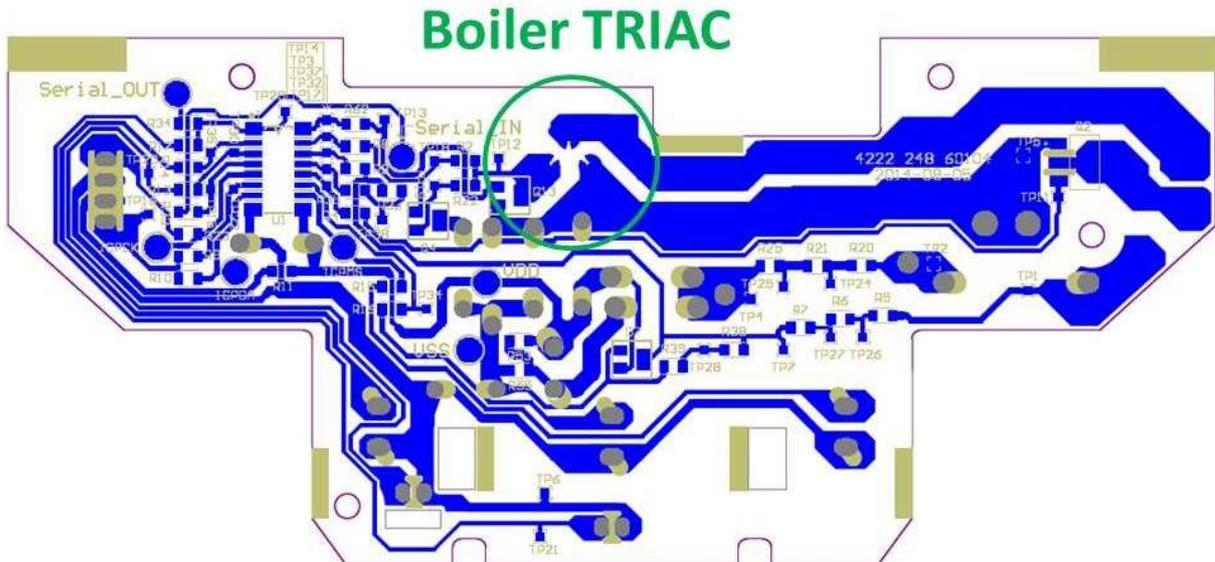
The cause for the Boiler TRIAC to blow, is likely to be an earth leakage of the boiler, therefore the boiler must be preventively replaced. Please refer to attached image for an overview of the back (solder side) of the PCBA, and the area to inspect.

CONL.
Apart from the PCBA

- 422225952721 HD7825
- 422225950632 HD7826/1x
- 422225952721 HD7826
- 422225947313 HD7827
- 422225948881 HD7828
- 422225945043 HD7835

also replace the Boiler

- 422225952091 HV
- 422225949121 LV
