Service information

Reference no.: SDA_108016

Appliance does not heat due to blown boiler TRIAC SCS

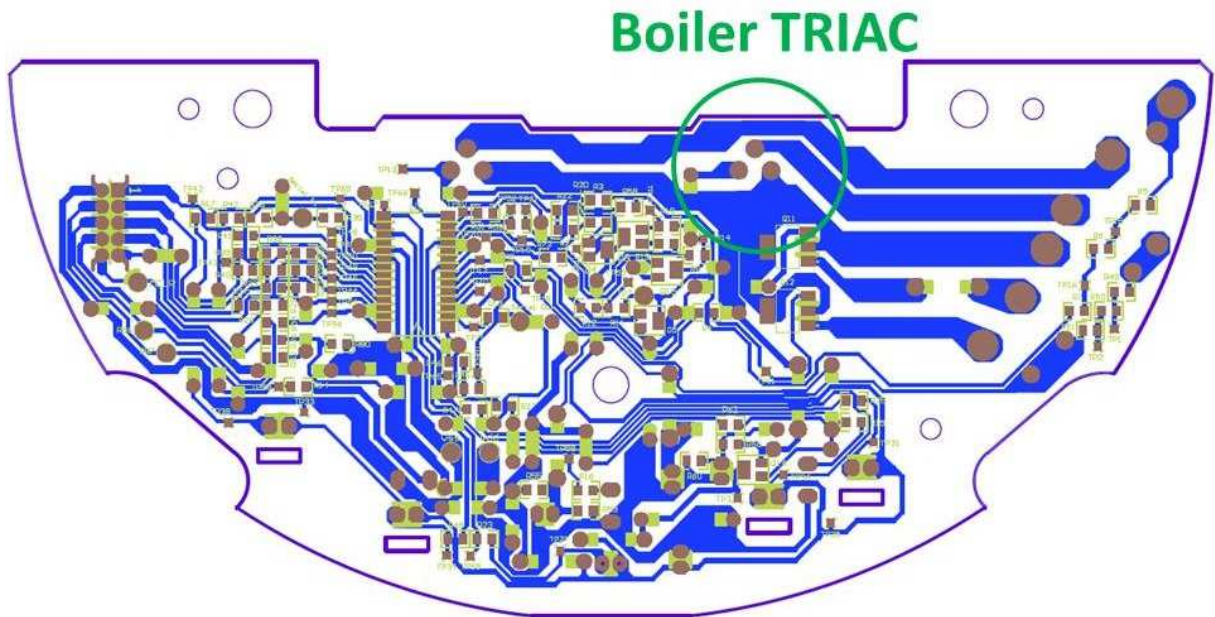
The cause for the Boiler TRIAC to blow, is likely to be an earth leakage of the boiler, therefore the boiler must be preventively replaced. Please refer to attached image for an overview of the back (solder side) of the PCBA, and the area to inspect.

Apart from the PCBA

- 422225955011 (Brasil HV, Korea)
- 422225955001 (Brasil LV)
- 422225950288 (WEU)

also replace the Boiler

- 422225952091 HV
- 422225949121 LV
