Reference no.: SDA_108017

Service information

Appliance does not heat due to blown boiler TRIAC SLS

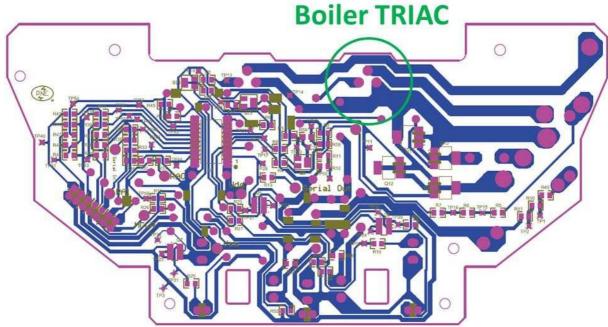
INFO:
The cause for the Boiler TRIAC to blow, is likely to be an earth leakage of the boiler, therefore the boiler must be preventively replaced. Please refer to attached image for an overview of the back (solder side) of the PCBA, and the area to inspect.

CURE: Apart from the PCBA

- 422225954231 WEU422225954273 Brazil

also replace the Boiler

- 422225952091 Plastic HV422225949121 Plastic LV
- REMARKS: 30-09-2014: Intial version
