**Service information**

**Reference no.: SDA\_108018**

Appliance does not heat due to blown boiler TRIAC SLD

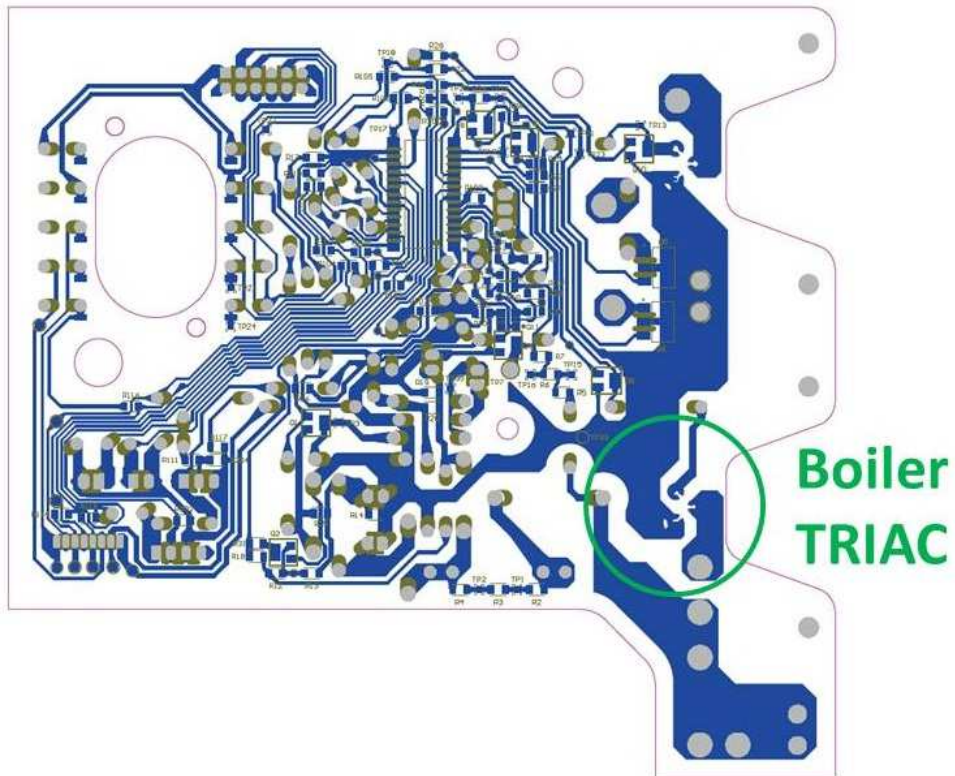
The cause for the Boiler TRIAC to blow, is likely to be an earth leakage of the boiler, therefore the boiler must be preventively replaced.

Please refer to attached image for an overview of the back (solder side) of the PCBA, and the area to inspect.

Apart from the PCBA

- 42225960301

also replace the Boiler

- 42225952091
