Reference no.: SDA\_108020

# Service information

Appliance does not heat due to blown boiler TRIAC ST

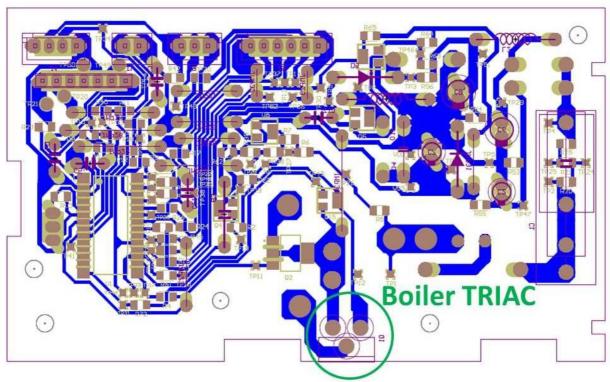
INFO:
The cause for the Boiler TRIAC to blow, is likely to be an earth leakage of the boiler, therefore the boiler must be preventively replaced. Please refer to attached image for an overview of the back (solder side) of the PCBA, and the area to inspect.

CURE: Apart from the PCBA

• 422225951853

also replace the Boiler

• 422225952091
