Service information

Reference no.: SDA_109342

Conveyor clogged by coffee powder in XSmall Vapore

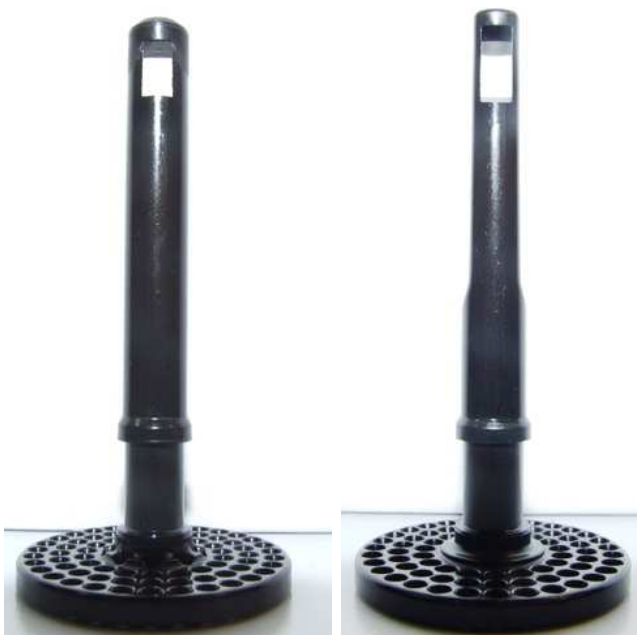
Replace the piston, 11003077, 421941154921 (image1), with the new one, code: 421944025621 (image2).
(Image1) (Image2)

Piston component improved to solve the problem of conveyor occluded.
