Service information

Reference no.: SDA_113915

Alarm for "Close Service Door" doesn't work.

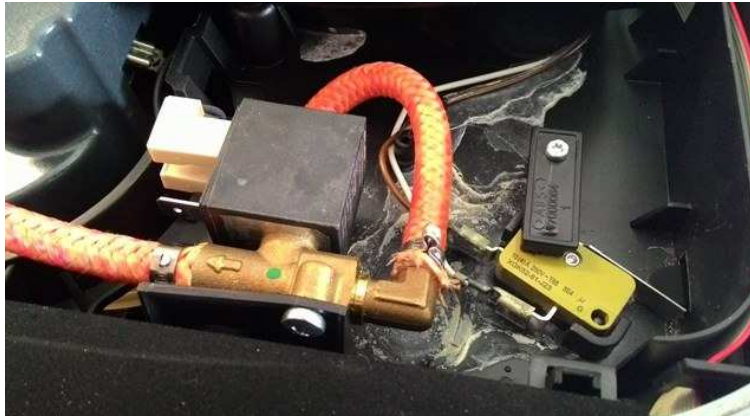
Image 01

- Alarm does not show up if Service Door is opened
- Alarm "close the service door" is always on (Image 01).

In all Intelia, Intuita Moltio and Gaggia Naviglio machines a possible leakage of the solenoid valve can cause an oxidation of door microswitch:

Actions: After repairing/replacement of the solenoid valve, order the microswitch including the cable (assy. Image 2)
Code: 421946000111 DOOR MICROSWITCH V3 NPR UL ASSY
