Service information

Reference no.: SDA_78805

Mains switch does not operate

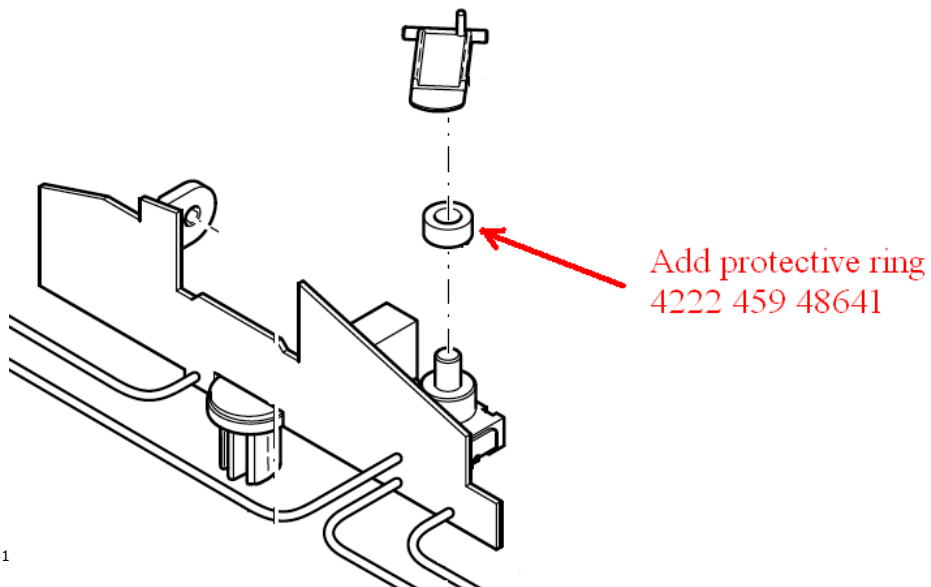
From market returns it became clear that the mains switch gets damaged using too much force on the on/off button!

Appliances are from now on equipped with a protective ring (see attached image). If this ring is missing it must still be placed as modification.
Sparepart code 4222 459
