Service information

Reference no.: SDA_85833

Defective capacitors on power boards

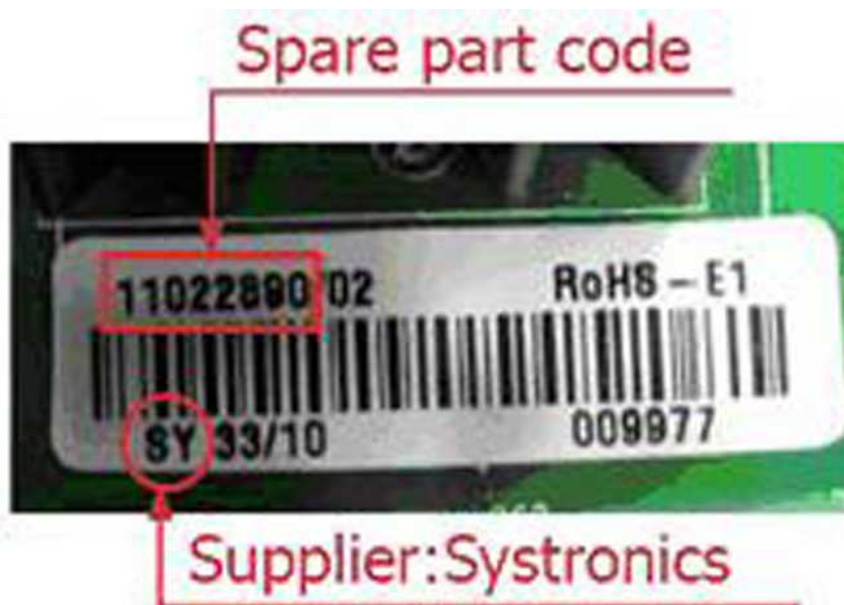
Problem with power board of supplier Systronics, "SY", that can cause different kind of functional symptoms to Xsmall, Odea Go, Talea, Syntia Cappuccino and Gaggia Unica espresso lines. To identify the supplier of the board, check the data label on the board (image 1).

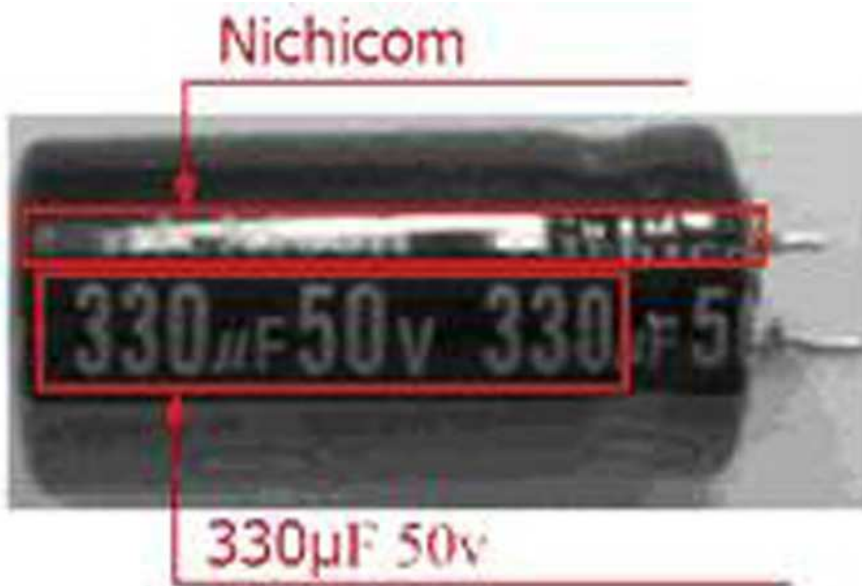
Image 3

If on the Systronic's power board there is in the position mentioned below (image 2) the capacitor 330µF 50V, of supplier Nichicom (image 3) that has the initials "H0935" (image 4), replace the board. Check also your spare part stock.

Code board	Position Capacitor
11022509	C14
11022788	C19
11022890	C14
11025142	C14
