Service information

Reference no.: SDA_85922

Coffee powder leakage caused by broken/detached conveyor

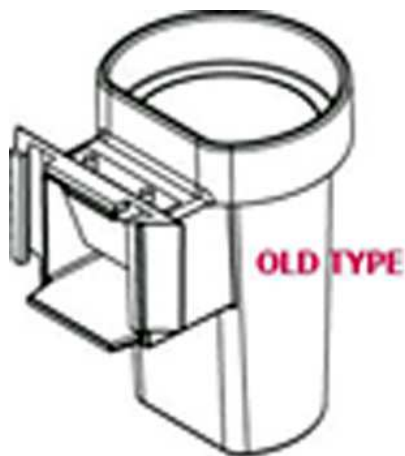
Image 1

Coffee powder leakage because of broken or detached conveyor in Incanto, Talea, Odea, Primea, Privileg Cafè Crema, Xsmall, Syntia, Spidem My Coffee, Espresso Italiano, Xelsis, MST Caruso, Spidem Flavia, Exprelia, Gaggia Platinum, Gaggia Brera, Gaggia Unica, Gaggia Cappuccino and Gaggia Accademia.

Replace the conveyor (image 1) of coffee grinder assembly by the strenghtened conveyor, part code 11026355 (image 2). Strenghtened areas shown in image 2.
