Service information

Reference no.: SDA_86221

Coating layer wear off due to abrasion of Basketholder Airfryer

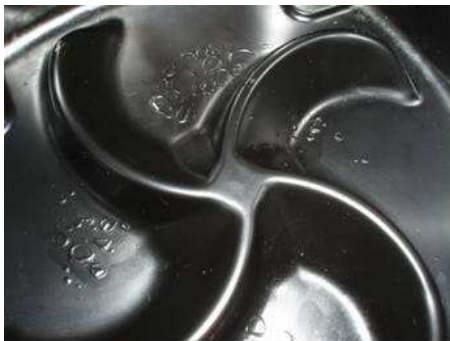
Symptom 1. Blisters at the bottom of the pan

Symptom 1: Blisters are caused by a production failure.

Symptom 1: Customer needs to receive a new pan. Symptom will not occur again with a new pan.

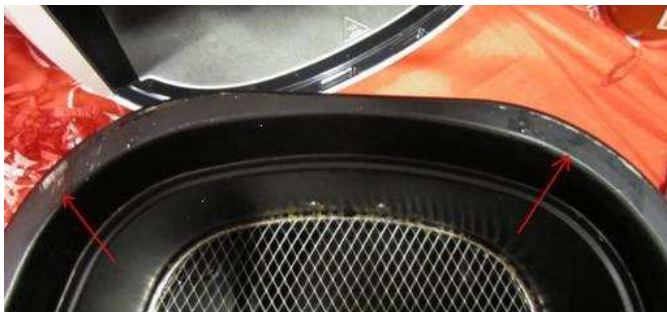
Symptom 2. Coating layer wear off due to abrasion from Basketholder (Pan)

Symptom 2: Issue is a known symptom caused by normal usage. Layer is damaged but no rust will occur and it doesnot have a negative and/or disadvantage effect on the taste of the food which will be prepared.

Symptom 2: Pan doesnot need to be replaced. Issue will happen again by normal use. Layer is damaged but no rust will occur and it doesnot have a negative and/or disadvantage effect on the taste of the food which will be prepared.

Symptom 2 will not occur anymore with appliances from production week 46 (2011) and onwards (change involves the use of a plastic part instead of metal guidance). However, it is not possible to change the metal guidance to the plastic guidance in the service centre because there are other several separate

parts that needs to be changed as well. Therefore, appliances from BEFORE week 46 (2011) will even after exchanging the basketholder/pan still have the same problem after some time as mentioned in the cure above.
