**Service information**

**Reference no.:** SDA\_86551

HD7740 Grind & Brew - Hinge cover in service part 4222 459 48321 doesn't fit

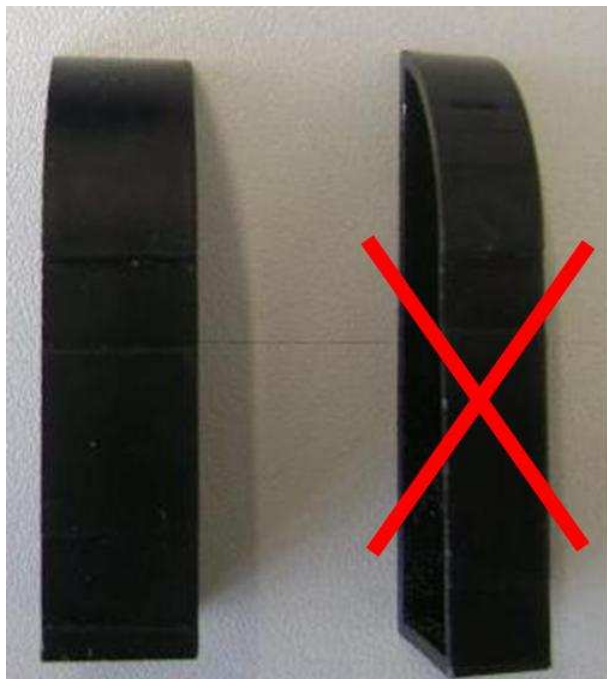
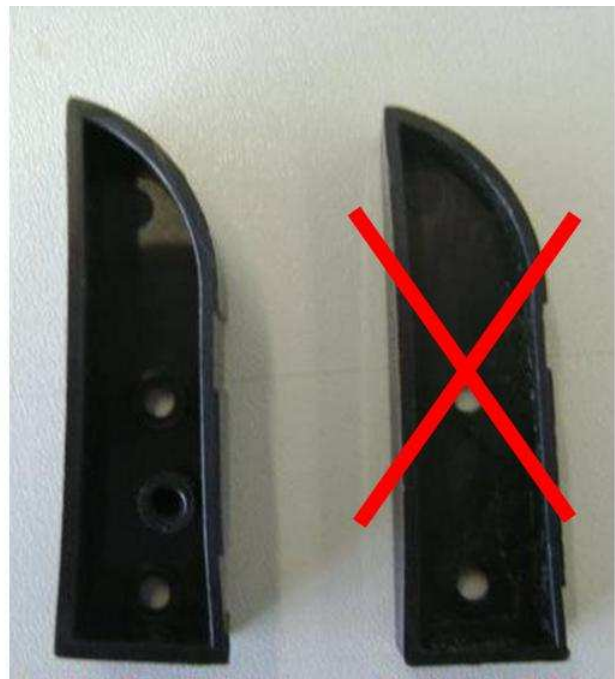
older housing, also a hinge cover and a sachet with two screws is supplied. Due to a mix up at the supplier a wrong model hinge cover might have been supplied. It was not possible to trace back the timeframe during which the wrong part had been supplied.

Exchange the Filter holder housing as you would normally do, but use the original hinge cover to reassemble the appliance.
