Service information

Reference no.: SDA_86702

Exhaust grill is getting loose during cleaning a certain time

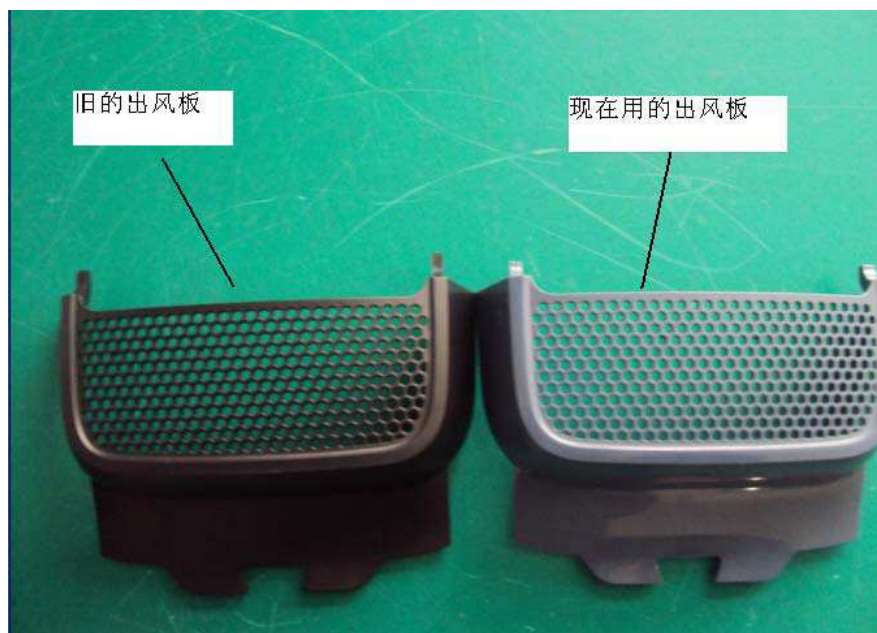
INFO: During the cleaning it can happen that Exhaust grill plops out because of the temperature.

See picture : left is old grille / right is new

CURE: Construction has been changed so that this problem will not occur again.

REMARK: When problem occurs : exhaust grill needs to be replaced by new one, 12 NC: 4222 459 47871
