### Service information

Reference no.: SDA\_89999

Mandatory - Replacement black coupling plate brew unit

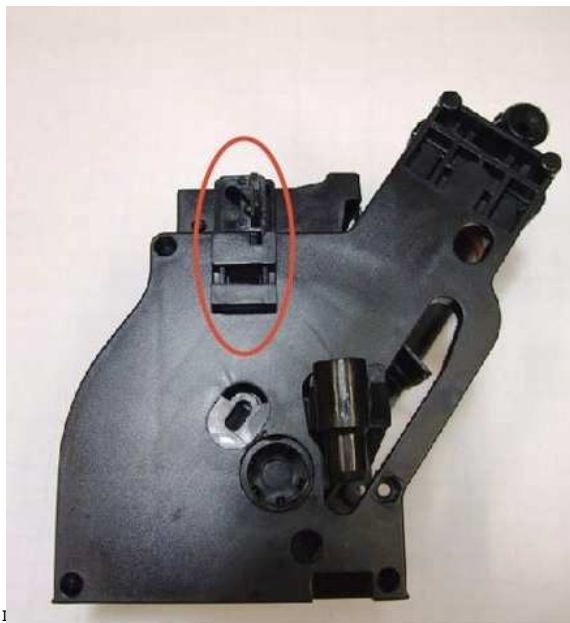
The coupling plate brew unit not seek the presence of micro brew unit.

Replace the brew unit code 11012382 having a black "coupling plate" (Image 1), with the brew unit code 11028890 having a grey "coupling plate" (Image 2)
