Service information

Reference no.: SDA_90839

Indication ventilate no waterflow noisy pump.

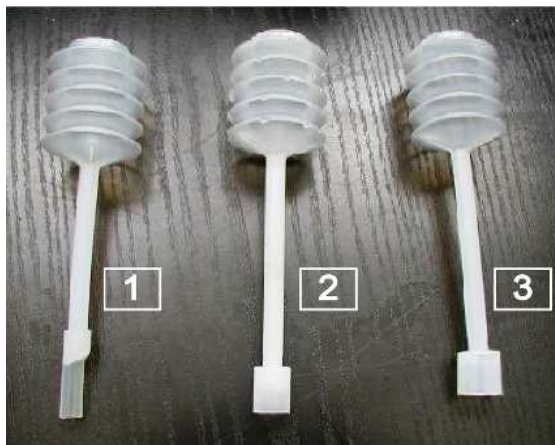
Image 1

After this procedure the pump should work properly. There are different pumps for different applications (see image 1) and these are the codes:

- 1 - this pump is obtained by cutting the pump 2 or 3 + silicone tube 6x8
- 2 - 996530016912 (saeco code 147700100) to use as image 2.
- 3 - 996530016913 (saeco code 147700200) to use as image 3.

In this case water has to be forced into the pump in order to ventilate the pump.
