Service information

Reference no.: SDA_91607

Spare filter door Grind & Brew

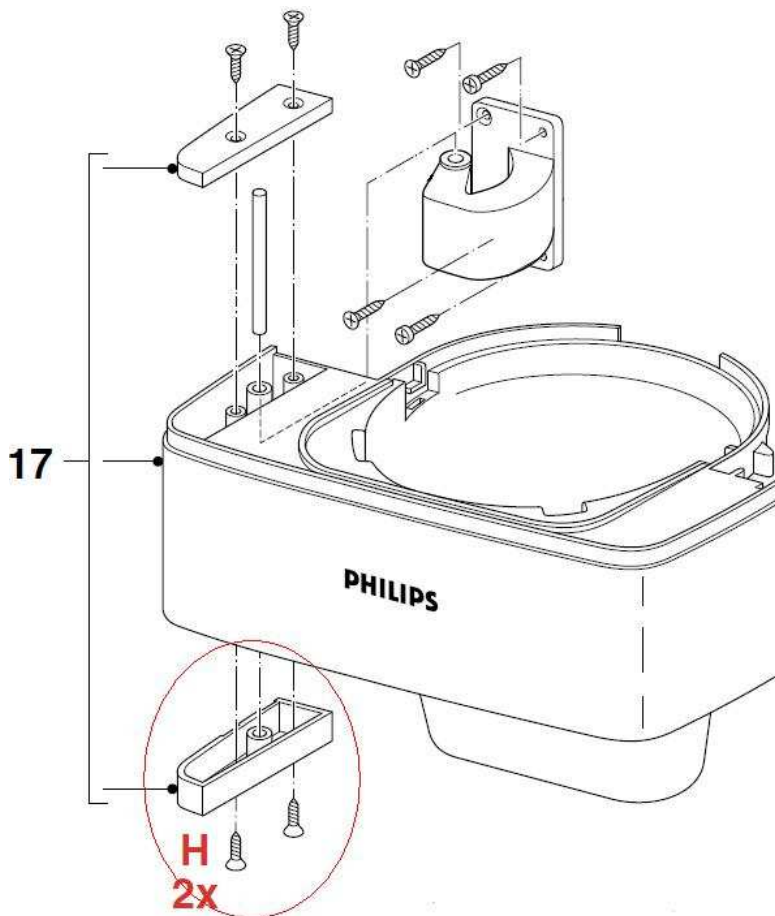
Due to a supplier error the initial shipments of the spare filter door for HD7740, HD7751 & HD7753 have been supplied with some additional components (cover for the hinge axle and two screws). These parts are officially no part of the spare part assembly, and will therefore no longer be supplied in new shipments from the supplier to DHL.

When you receive the spare from DHL, please transfer the cover and screws from the original filterholder to the new spare filterholder.
