Service information

Brewhead detection sensor snapped off

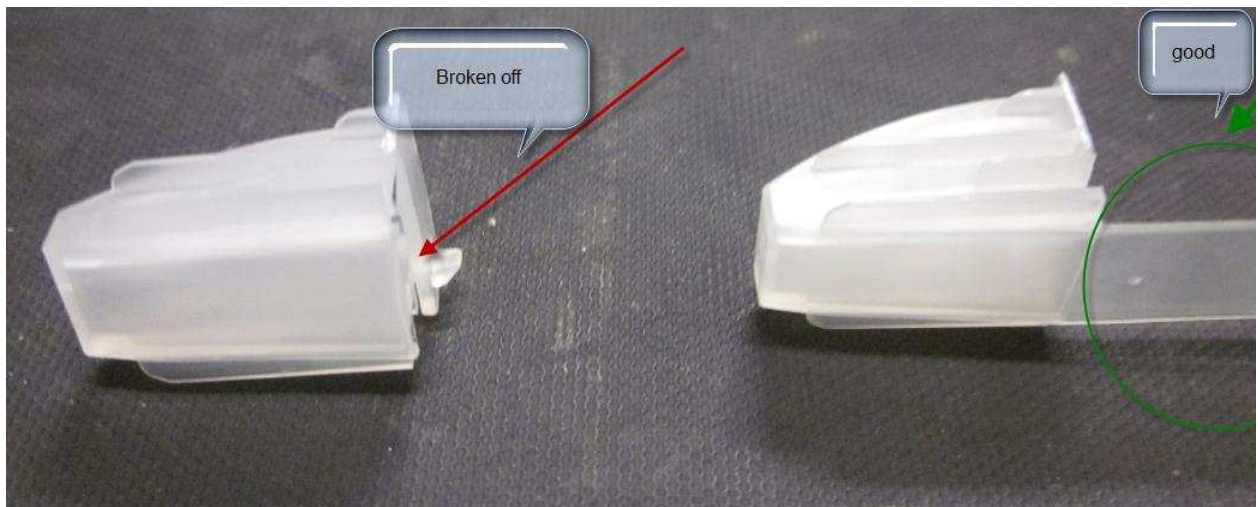
It has been observed that the sensors' fixation is not very securely. When opening the appliance it can fall out easily. when it is reinstalled incorrectly the indicated piece of plastic can easi
reinstalling the sensor incorrectly can be done quite easily. I will add the component (422224761601)to all partslists of Senseo Quadrante.
