Service information

Reference no.: SDA_91765

Mandatory- New top of upper cover casing in Gaggia Brera

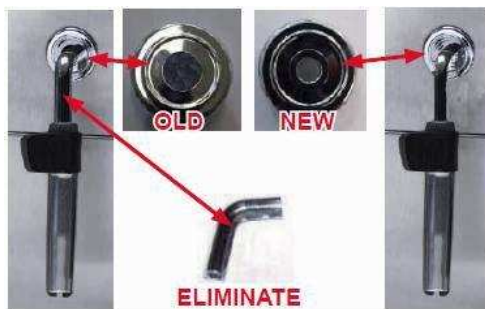
Possible cracking of chromium in the coverage of the steam wand in Gaggia Brera up to serial number TU9011029097424. The plastic chrome cover on the steam wand has been removed in the new Gaggia Brera production line, to avoid excessive clearance between the casing cover and steam wand, we also lowered the hole in the cap.

Remove the cover and insert the new cap with the smaller hole code 11027517. Also give the customer the attached sheet (pdf file attached) which gives an explanation about the piece which has been removed.
