### Service information

Reference no.: SDA\_92460

Trouble in the rinse cycle in Odea

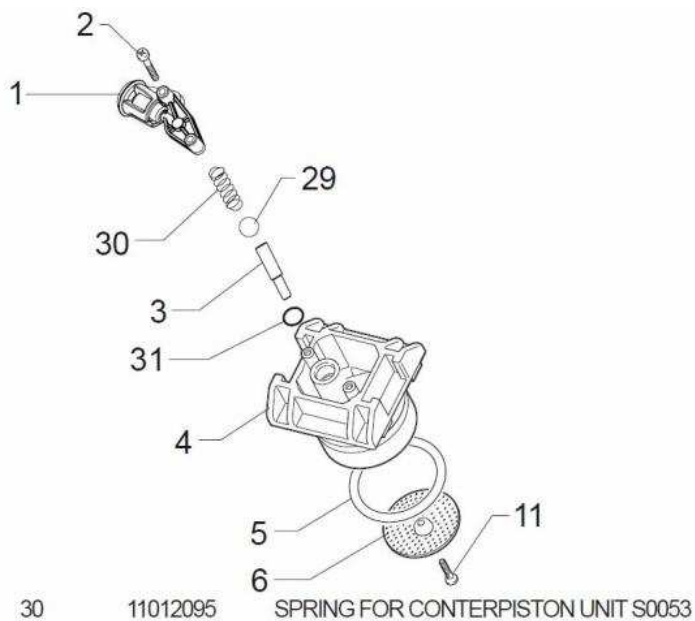
INFO:  
When the appliance doesn't complete the rinsing cycle showing the ventilate alarm check if the spring position 30 (Image 1) is bended (Image 2).

CURE:  
Replace the spring (position 30) cod. 11012095.
