Service information

Reference no.: SDA_95700

(New) Bread pan does not fit

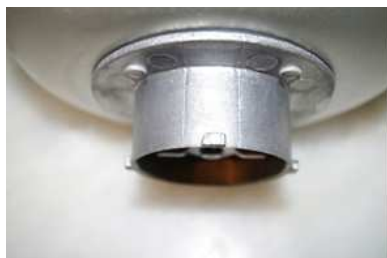
NEW BREAD PAN

CURE: When replacing the bread pan, **the old motor assy (4222 459 52291) should be replaced as well by a new one (under service number 9965 100 55822).**

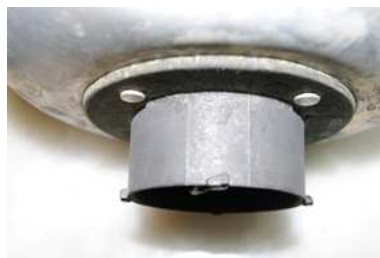
OLD BREAD PAN
