Service information

Reference no.: SDA_96591

Instruction for assembly of pwr board in Xelsis-Exprelia-Energica and Accademia machines

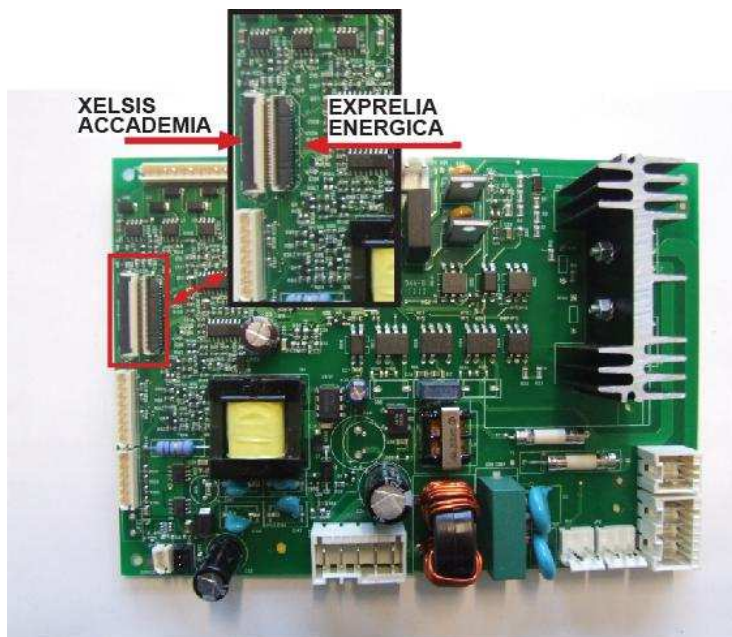
Image 1

The pwr board cod.11024263 has two different connections for flat cable: one for Xelsis - Accademia machines and one for Exprelia - Energica machines (see image 1).

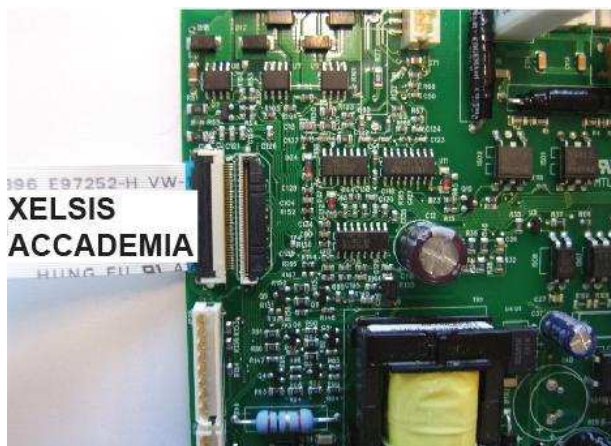
Image 2

Possible wrong connection of the flat cable on the pwr board in Xelsis-Exprelia-Energica-Accademia machines.

- 1) When replacing the pwr board in the Xelsis and Accademia machines insert the flat cable as indicated in Image 2.
- 2) When replacing the pwr board in the Exprelia and Energica machines insert the flat cable as indicated in image 3.
