Service information

Water is leaking out of the appliance FC7070

Reference no.: SDA_99172

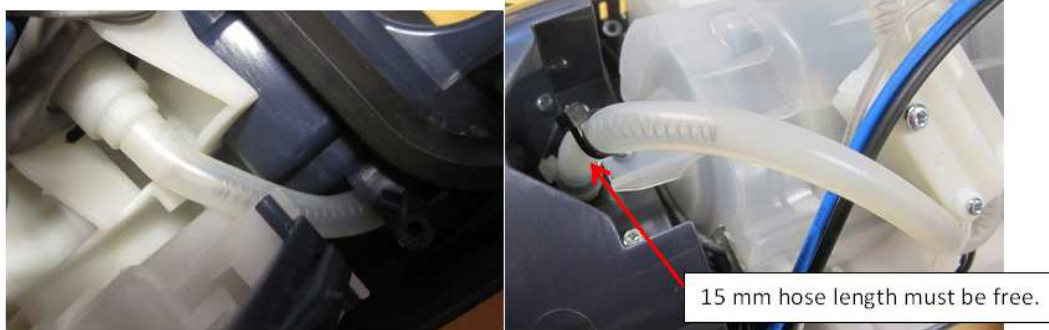
Proposal to ensure the water distribution in Aqua Trio by adding 2 springs in water hoses.
Goal is to avoid kinking of the water hoses which cause lack of water.

Add a spring to the water hose from the clean water tank outlet to the water sensor.
The spring can be the same as the present used springs (4322 000 00371).
The spring must be fixed with a Tie wrap (4322 001 75211).
The distance is +/- 15 mm from the end to ensure that there is enough hose length to push the hose on the inlet piece.

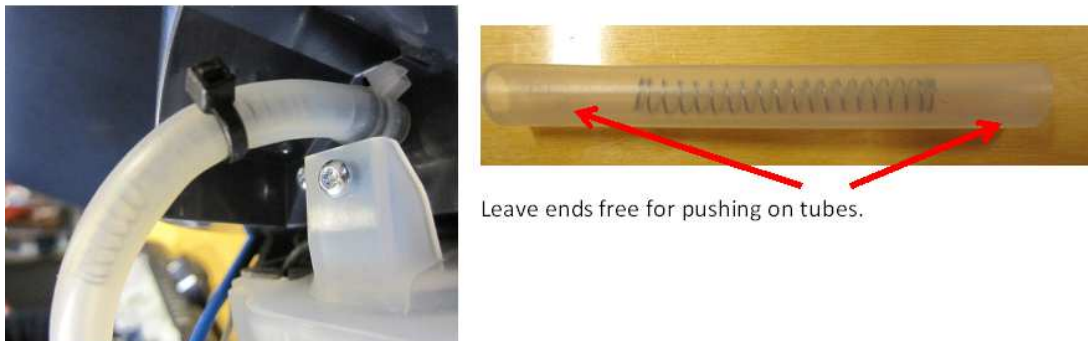
Goal is to avoid kinking of the water hoses which cause the leakage of water.

Add a hose spring to the hose from the water pump to the water inlet piece to the brush.
Use the same spring (4322 000 00371) as already used.
The spring must be fixed with a Tie wrap (4322 001 75211).
Therefor the used hose should be replaced by the same hose (inner and outer) diameter as used for water distribution in the lower stick.
Length must be the same as present pump outlet hose.
